**REPORT
SUNDBYBERG KOMMUNHUS, EVALUATION OF OPEN
PLAN OFFICES ACC. TO ISO 3382-3**

253520, Sundbyberg, mätning av rumsakustiska parametrar enligt SS-EN 3382-3

Sundbybergs Kommunhus, Measurement and evaluation of room acoustic parameters in open plan offices acc. ISO 3382-3:2012

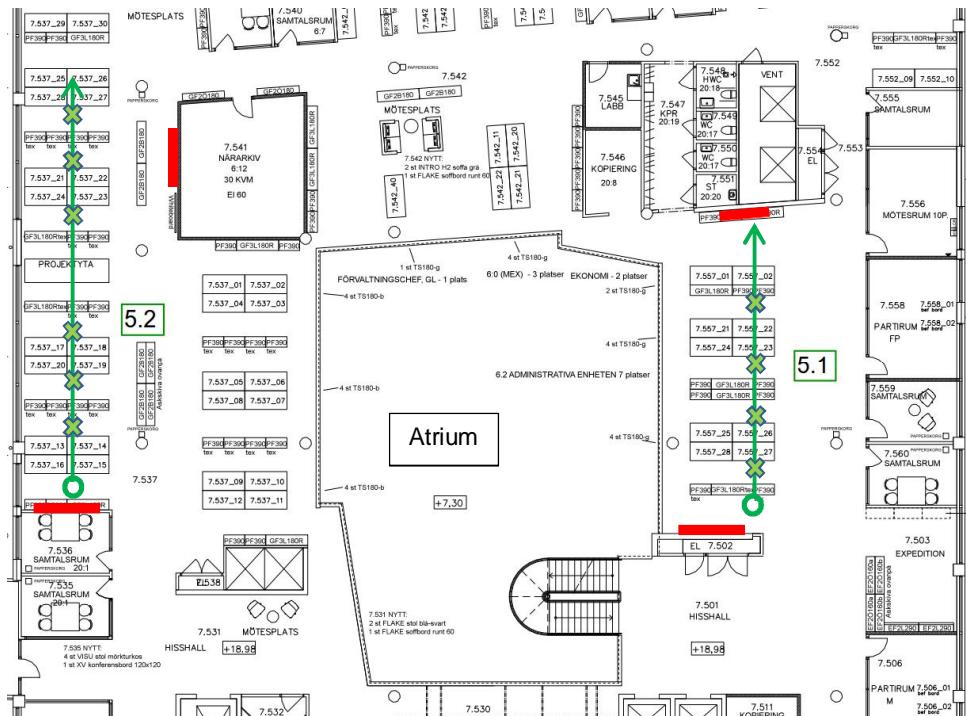
Figure 2 Location of measurement paths and on floor 5. Sound absorbing wall segments are marked with red.

Measurements were carried out along four measurement paths, two of the paths are situated on the floor 4 (path 4.1 and 4.2) and the other two on floor 5 (path 5.1 and 5.2). Sound source- and measurement positions are presented in Figure 1. Office floors are acoustically connected by an open atrium, situated in the center of the building. Measurement path 4.1 and 5.1 are situated in close proximity to the atrium.

For the acoustic condition with complementary sound absorbing segments the wall surfaces marked with red in Figure 1 and 2 were partly covered with 40 mm Ecophon Wallpanel, see Appendix 1 for sound absorption data.

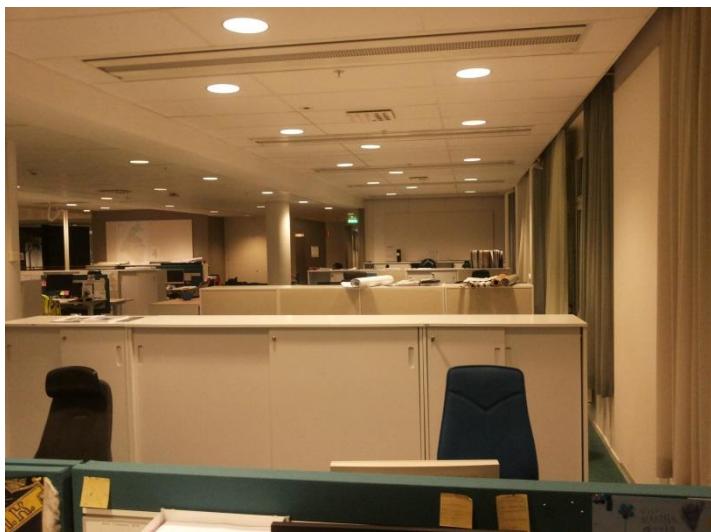
Figure 3 Measurement path 5.2, Acoustic condition 3 – sound absorbing ceiling with complementary wall absorption

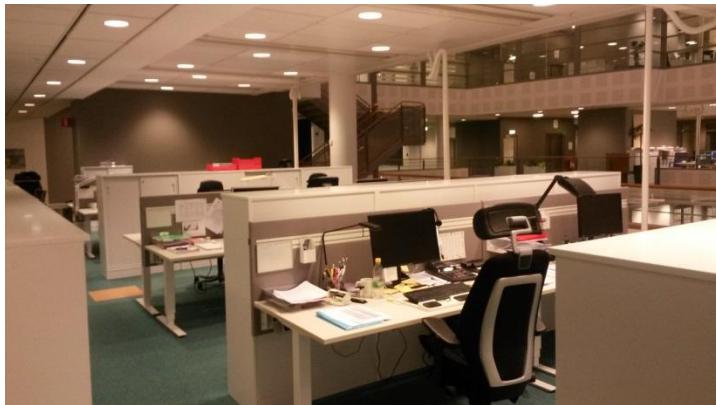
Figure 4 Measurement path 5.1 – Acoustic condition 1 – partly reflective ceiling

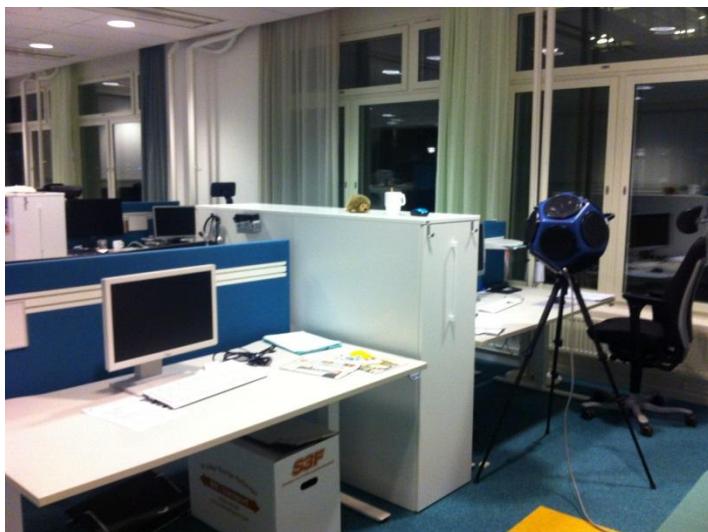
Figure 5 Measurement path 4.2 – loudspeaker placement
